Manhole Inspection Summary

Manhole # S37MM_030MH

Location Address: **2026 GREENMOUNT AVE**

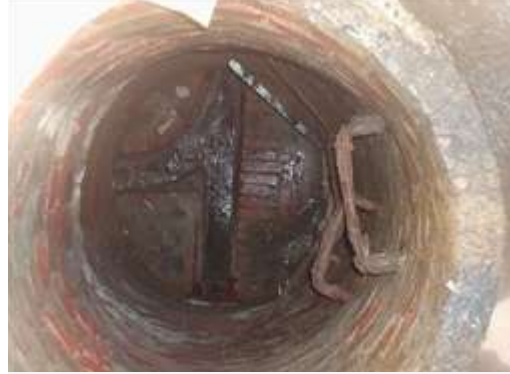
Top View

Corroded steps. Evidence of surcharge - Bench debris.

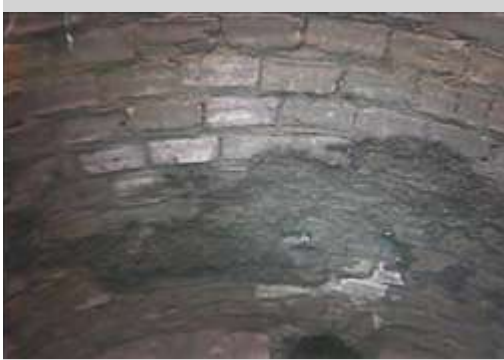
Defect

Barrel infiltration.

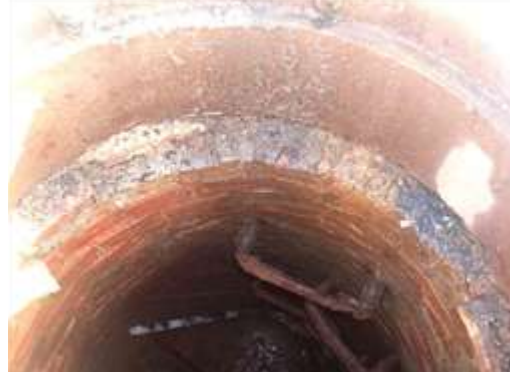
Defect

Frame leaks. Frame offset. Adjustment deterioration, loose brick and infiltration. Corbel infiltration.

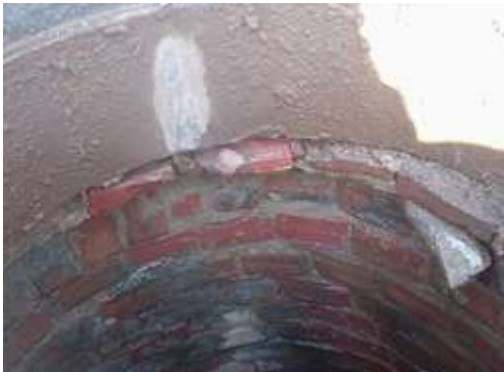
Defect

Frame leaks. Adjustment deterioration, loose brick and infiltration. Corbel infiltration.

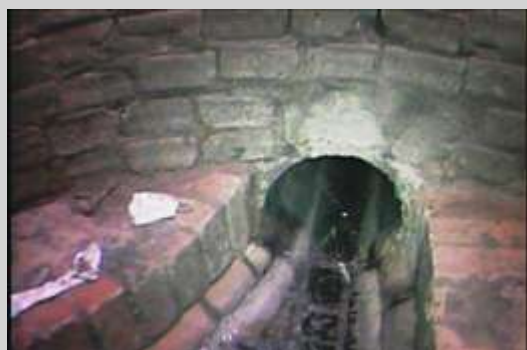
Pipe Out @ 12 O'Clock

Barrel deterioration and infiltration.

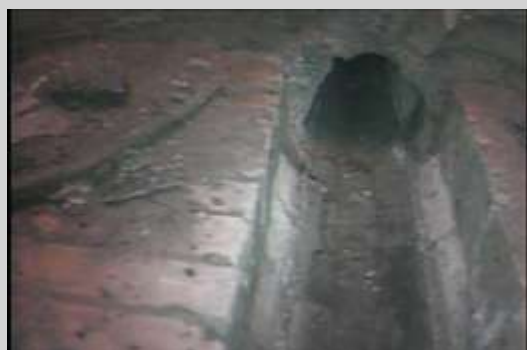
Pipe In @ 6 O'Clock

Deposits: ☐ None ☒ **Mud** ☐ Sludge ☒ **Debris** ☐ Grease

Silt Depth: **0.5** (in.) Deposits Extent: **Light**

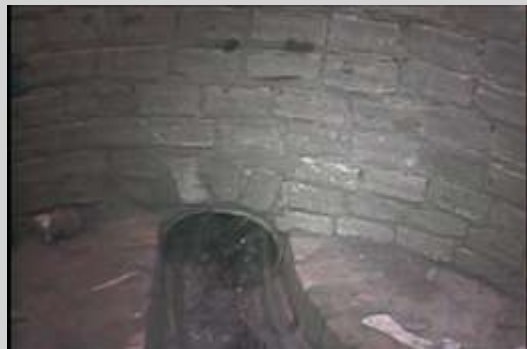
Pipe In @ 9 O'Clock

Infiltration: **Evidence**
